2024 Annual Fall Protection System Inspection Report	
Inspection Dates:	June 20, June 21 & June 26, 2024
Report Issue Date:	July 2, 2024
Client:	Cushman & Wakefield
Project Address:	777 East Wisconsin Avenue, Milwaukee, WI 53202
Building Name:	US Bank Tower (16 th Floor & 41 st Floor)
ZS Project Number:	247115
Attention:	Mr. Dennis Kelley (Chief Engineer)

US Bank Tower – 16th & 41st Floor HLLs
2024 Annual Fall Protection System Inspection Report
July 2, 2024

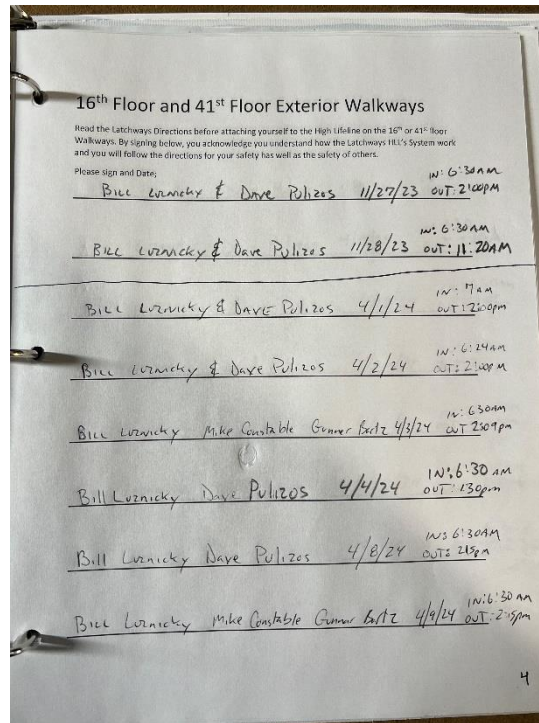
Item Description	Quantity	Photo(s)	Category (OSHA Compliance or Maintenance)
The Use Log shows usage of the HLL system beyond the 1-year annual inspection approval date 03/01/2024. Between 04/01/2024 & 05/31/2024.	15	1-3	OSHA Compliance The HLL system should not be used beyond the annual inspection date approval of 03/01/2024, until the next annual inspection is performed.
Peeling label on Transfastener	1 (3)	4	Maintenance Replace the peeling label.
Multiple missing yellow buffers on multiple Transfasteners	3 (1, 3 & 4)	5	Maintenance The missing yellow buffers should be replaced on multiple Transfasteners.
Both HLL systems were only certified for usage with only 2 workers on each HLL at a time.	-	-	Observation Only 2 workers are permitted to work on each HLL at a time.

Photo 1: 6 days of usage (Page 4) beyond March 1, 2024.

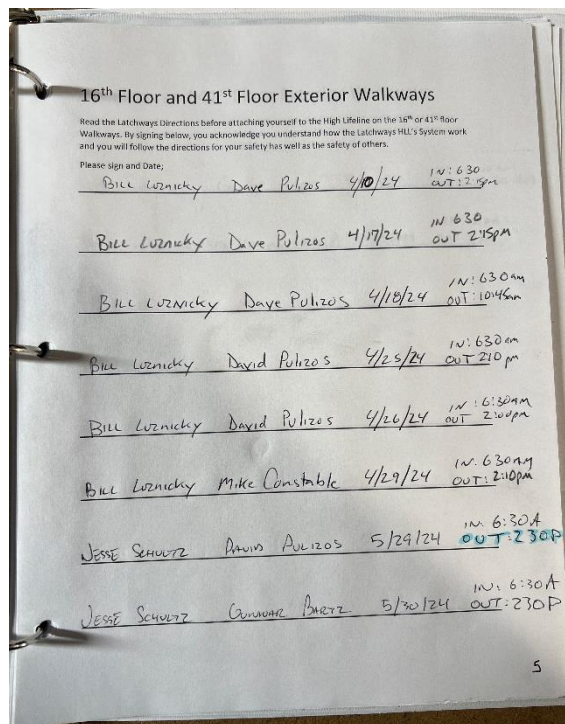
Photo 2: 8 days of usage (Page 5) beyond March 1, 2024.

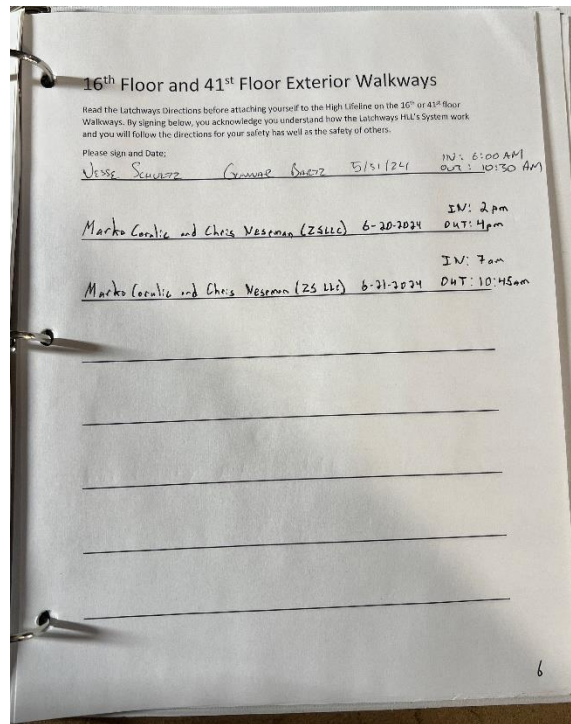
Photo 3: 1 day of usage (Page 6) beyond March 1, 2024.

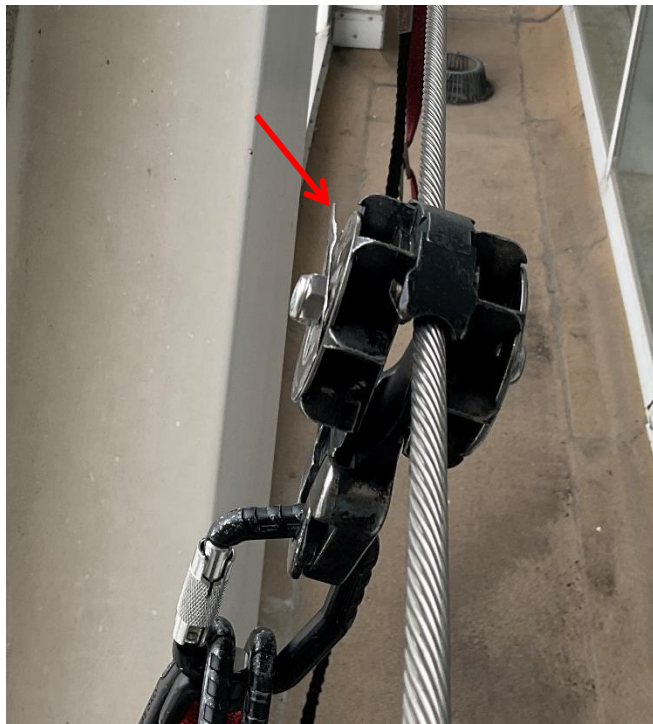
Photo 4: Peeling label on Transfastener #3.

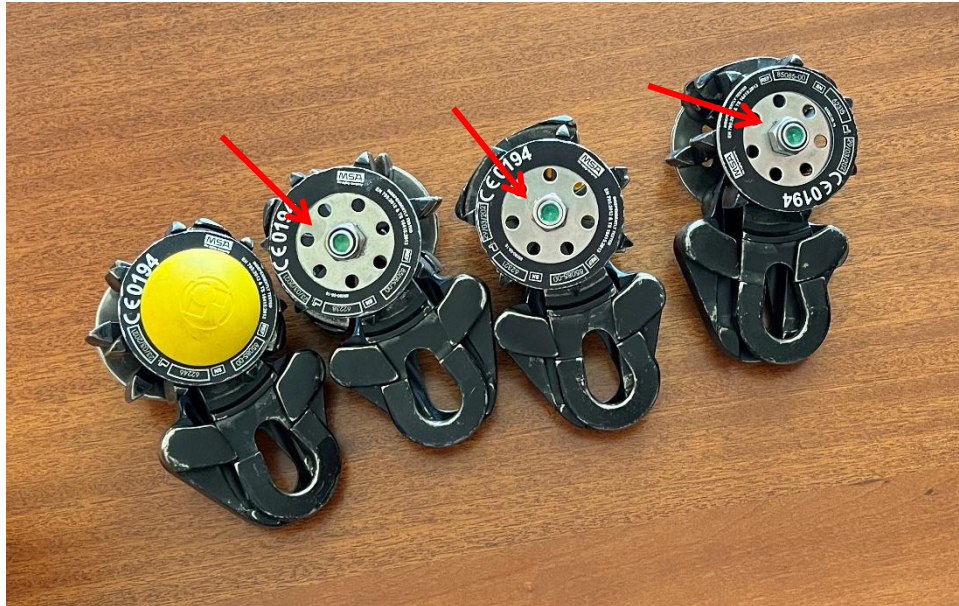
Photo 5: Multiple missing yellow buffers on multiple Transfasteners. TYP.
