<b>2025 Annual Fall Protection System Inspection Report</b>	
<b>Inspection Date:</b>	February 28, 2025
<b>Issue Date:</b>	March 27, 2025
<b>Client:</b>	UChicago Medicine
<b>Project Address:</b>	14290 LaGrange Road, Orland Park, IL 60462
<b>Building Name:</b>	UChicago Medicine Orland Park
<b>ZS Project Number:</b>	257031
<b>Attention:</b>	Ms. Jennifer Palmer-Palombizio, MS (Manager, Environmental Health and Safety)

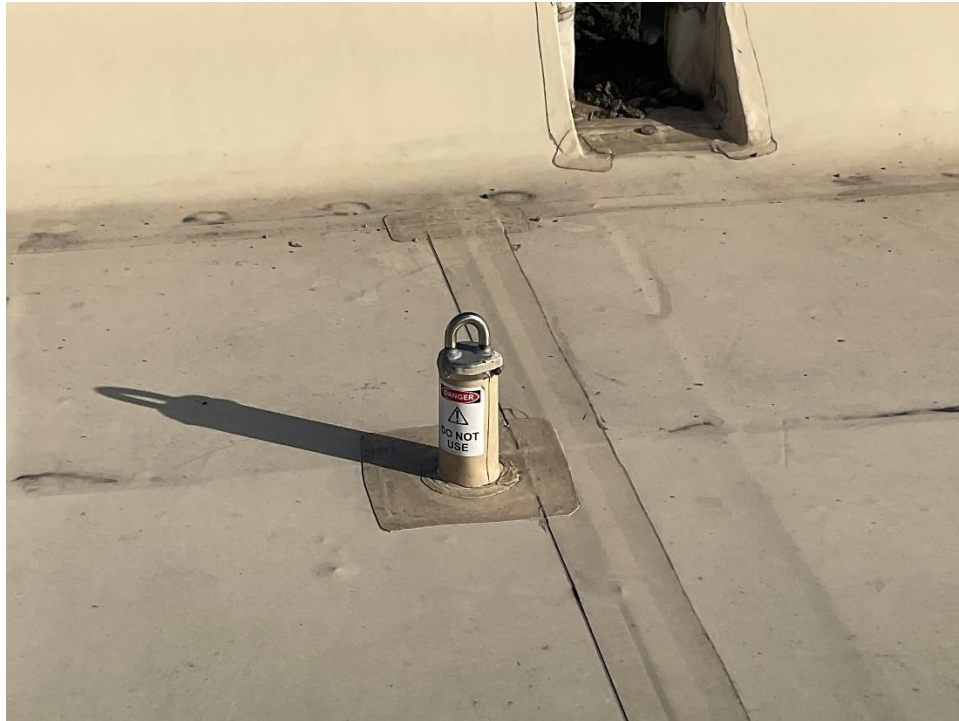
Photo 1: Uncertified single point fall protection anchor tagged with a DANGER – DO NOT USE sticker. Typical.

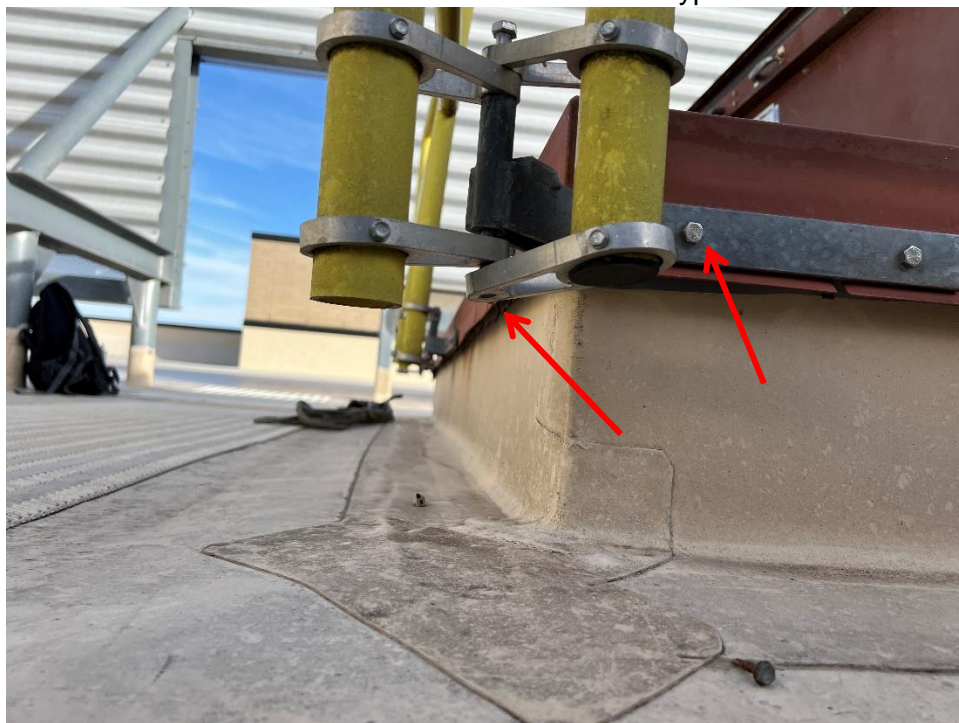
Photo 2: Missing locking nut at the corner connection. Typical.  
No washer at the bolted connection. Typical.

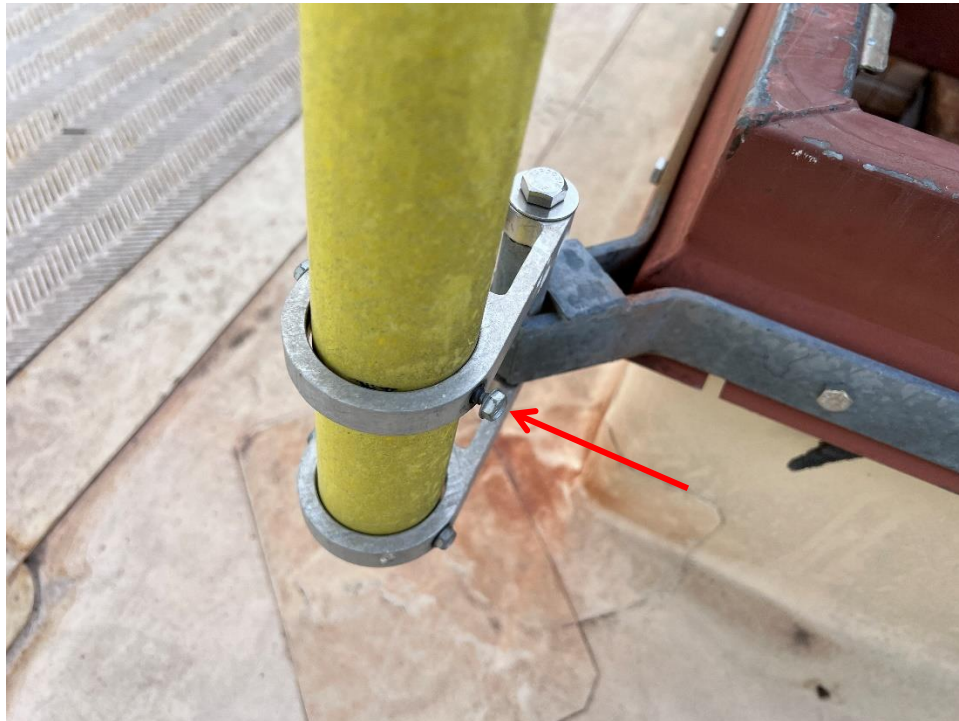
Photo 3: Loose self-tapping screw. Typical.

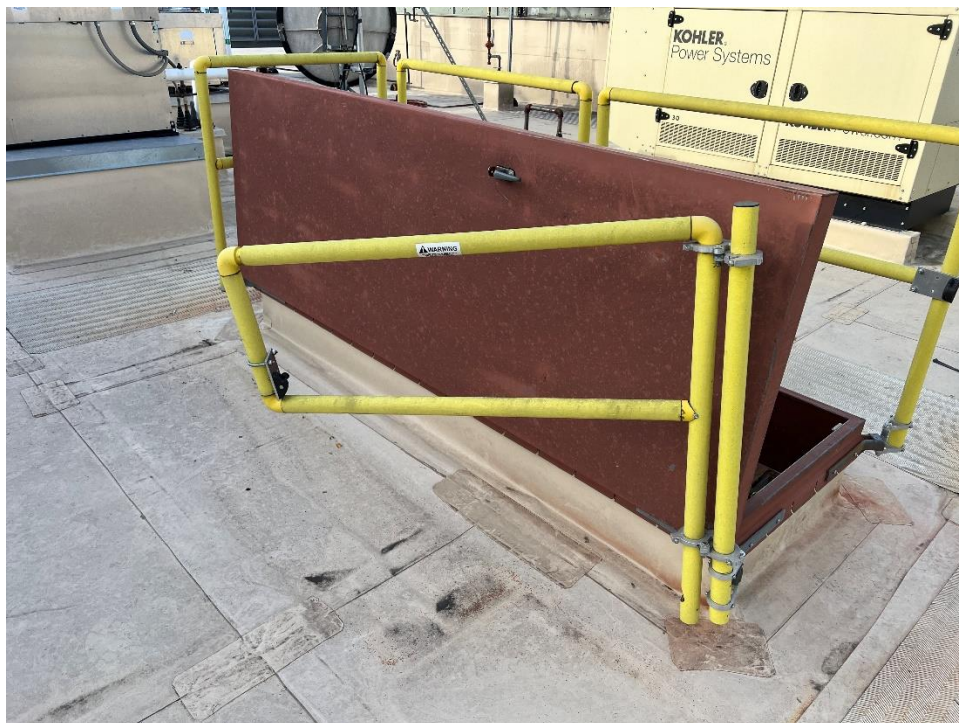
Photo 4: Self-closing swing gate does not close on own.

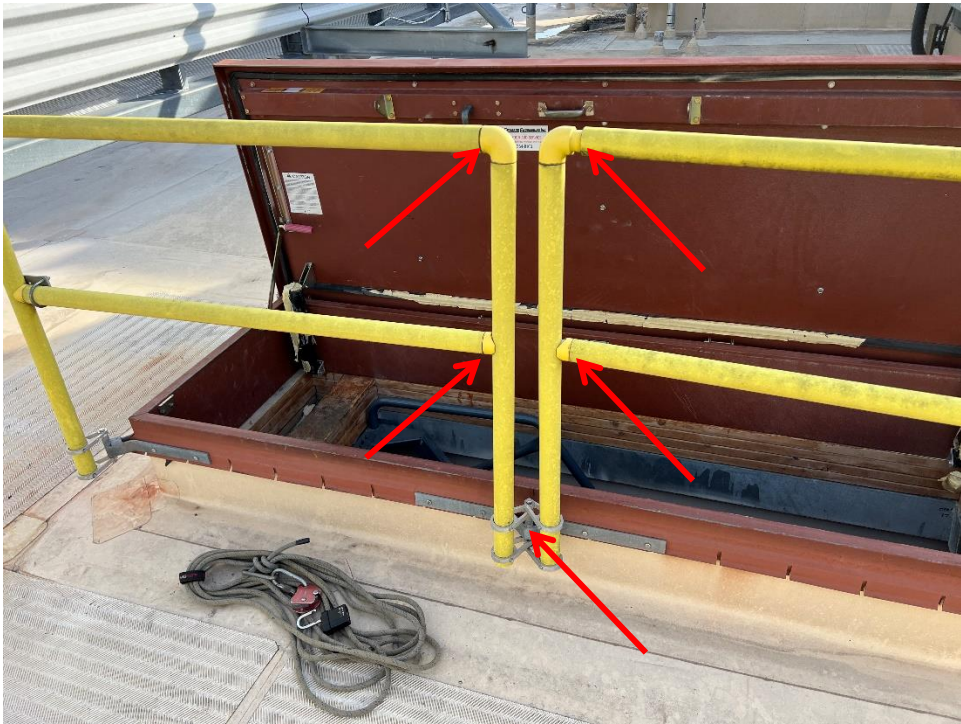
Photo 5: Multiple loose railing sections. Typical.

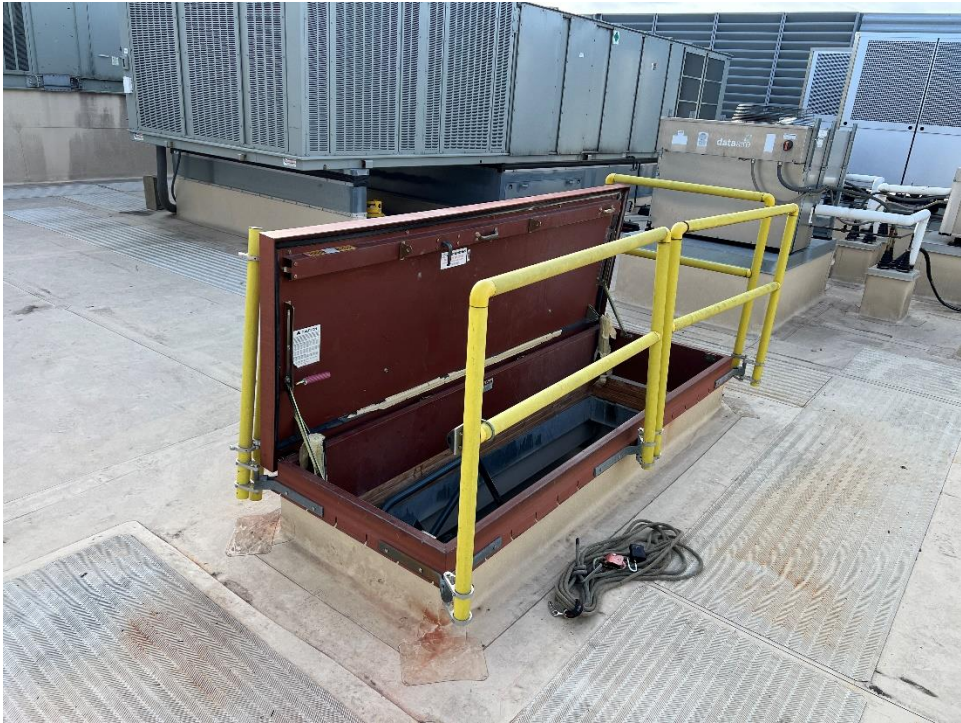
Photo 6: Non-compliant roof hatch access.

Access to Roof Area	1	6	<p><b>OSHA Compliance</b></p> <p>Since the roof hatch railing system is not compliant, the roof hatch should not be used until the safety railing system around the roof hatch can be properly repaired.</p>
General - Post fall protection system drawing by roof/system access point	1	7	<p><b>OSHA Compliance</b></p> <p>Post the fall protection system drawing by the roof/system access point.</p>

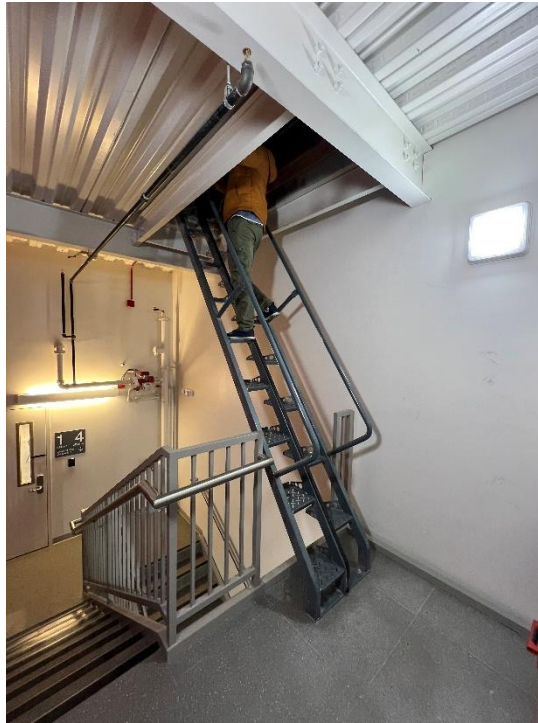
Photo 7: No fall protection system drawing present by the roof/system access point.
